BELK DECLARATION--

According to my commission in this matter I offer this declaration of facts and opinion in Case No. 13-0086-CV-W-ODS

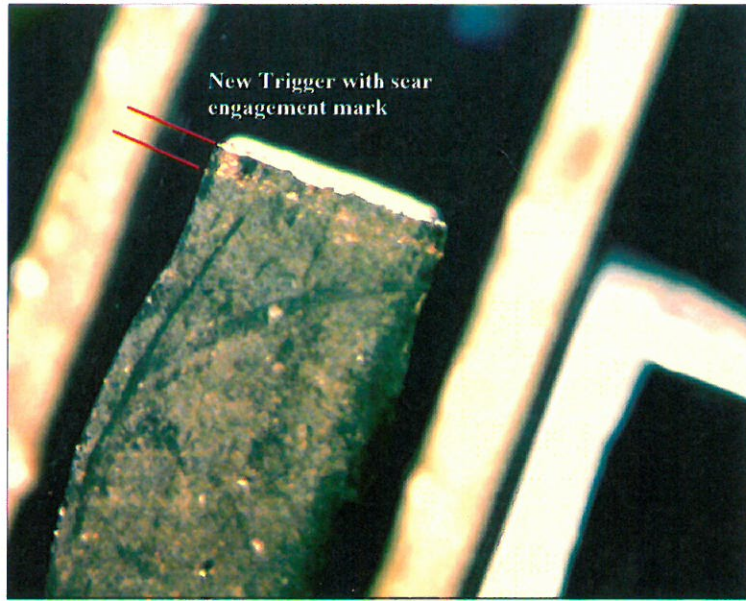
Casual visual observation was of a lightly 'used' trigger due to a smear of metal on the top surface of the sear and a light mark across the top of the trigger.

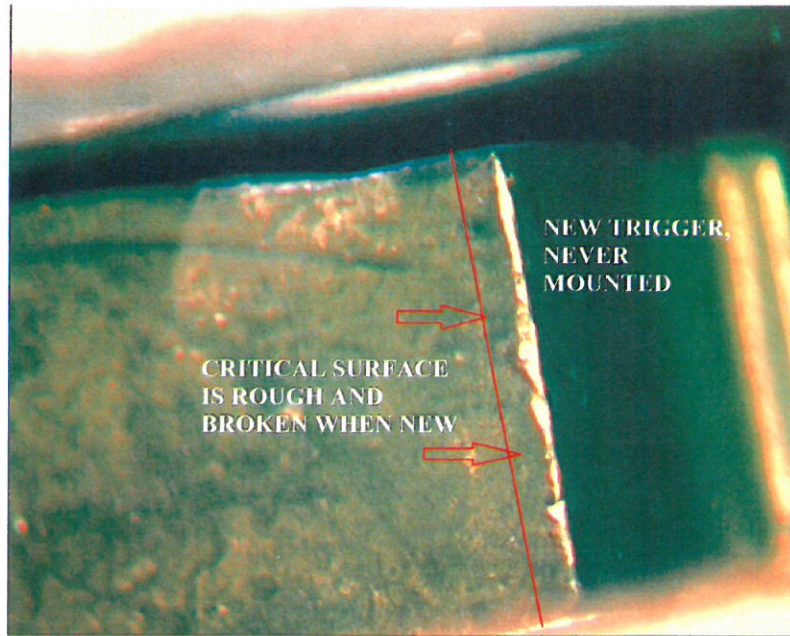
Casual visual inspection of the critical trigger corner showed 'sparkles' of small breaks. Microscope examination and photography shows a trigger corner that most gunsmiths would recommend replacing with a new trigger. (pictures)

It is unknown if this damage was caused by testing, there is a sear mark on the new trigger, or possibly suffered impact damage during manufacture, shipping or storage.

The dents and chips seen in the critical edge of the trigger is something new in Remington triggers and have only been observed by this gunsmith in XMP triggers. Model 788 triggers with severe use will show some polish and rounding, but I've never observed breakage. The active connector corner in Walker triggers will polish in several thousand rounds but I've never had to replace one.

The chipping seen in the new 'unfired' trigger is exacerbated by the less than 90 degree angle of the critical corner. The acute angle is unnecessary to the design and detrimental to the strength of the most critical corner in the entire rifle. The acute angle makes an inferior material even more susceptible to breakage.

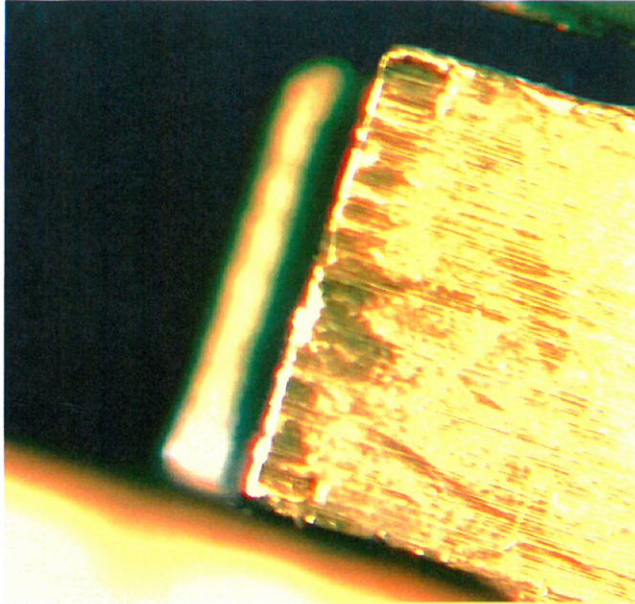
XMP after 100 pulls.

Inspection showed bright smearing of the electroless nickel plating of the critical corner of the trigger.

The sear overlap area could be plainly seen. The toughness of the plating is evident in the high places taking abuse from the sear, but only the high places. There was no further chipping or flaking detected, but the sharp corners of previous breaks were rounded a slight amount. Photographs were taken but not of good quality.

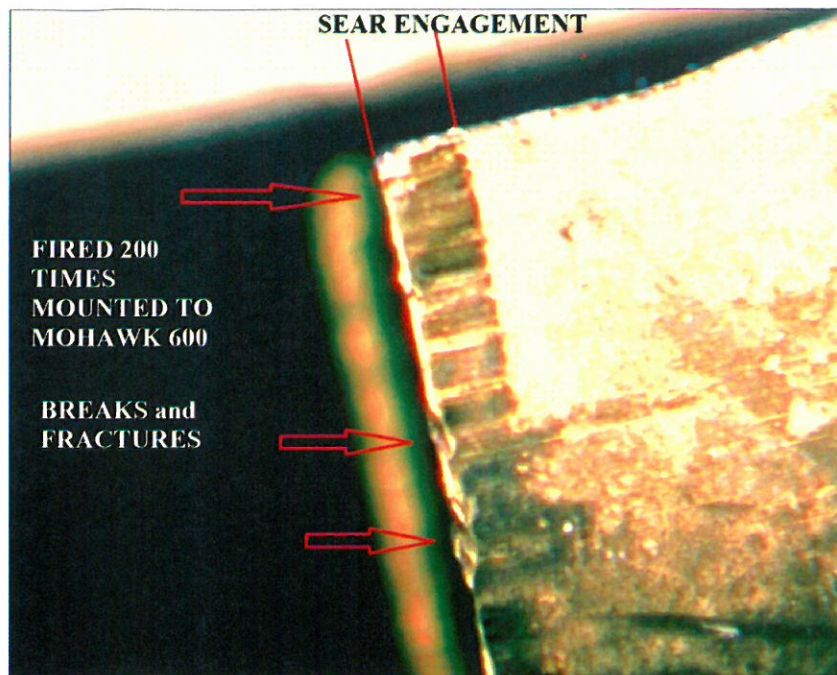
The trigger surface was further polished and smeared by the sear and the increased area of the smears seemed to reach a parity with the abrasive resistance of the plating. A further test of one hundred more pulls showed the surface wear had slowed considerably. It is not known if a slight transfer of lubrication was made during the inspections between shot series but that is likely and such a very slight amount of lubrication will obviously increase the life of the critical trigger surface.

The chips and flakes and dents present when new have been rounded and worn so that a portion of the edge is worn away, more than likely matching a corresponding profile in the active sear edge, but that was not confirmed or attempted.

No additional chips from the edge are seen.

From my extensive experience in the field of wearing of hard steels in the gun industry as well as mining, timbering and steel making itself, the wear patterns seen in the test trigger indicates less than half the life of the trigger has been expended, but the wear showing is much more than should be expected from traditional trigger materials. The XMP trigger is made of inferior materials.
